Incident Investigation of Firefighter Death During a Training Fire Port Everglades, Florida

**Prepared by the
Bureau of Fire Standards and Training
Florida Division of State Fire Marshal
BFST Safety Investigative Report 03-01**

Issued February 9, 2005

Incident Investigation - Training Fire at Port Everglades
Miami-Dade Fire Rescue Department and City of Hialeah Fire Department
August 8, 2003, Hollywood, Florida
Prepared by the
Florida Division of State Fire Marshal
Bureau of Fire Standards and Training

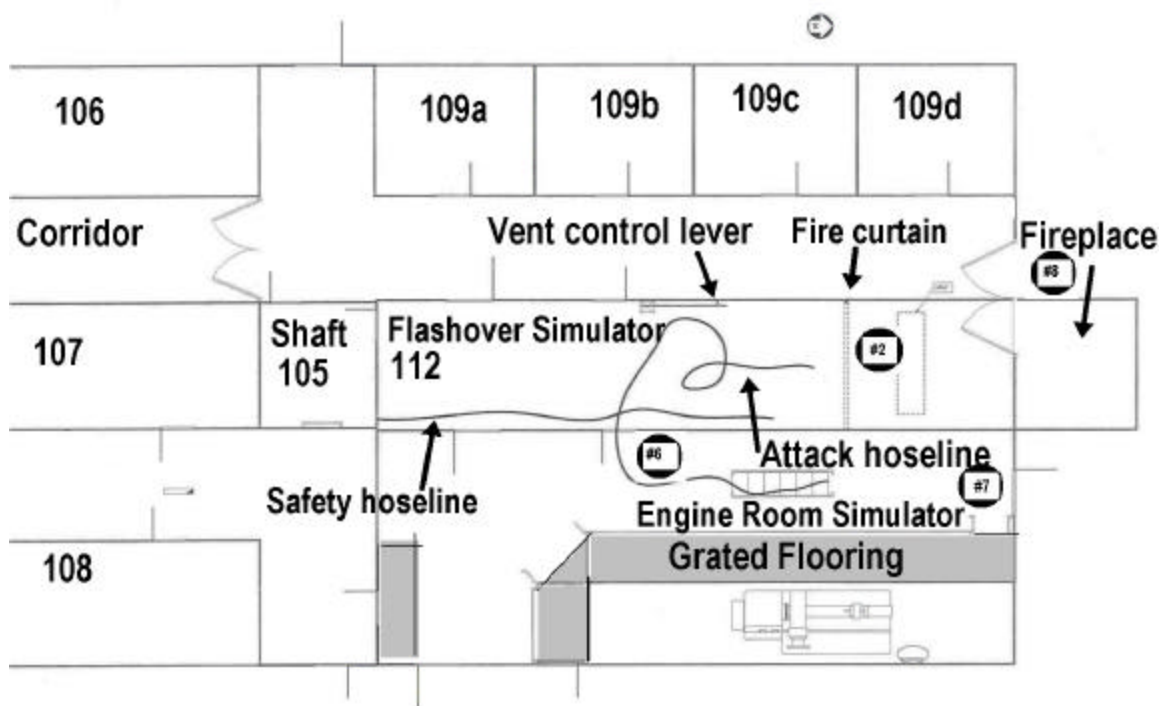
Figure 3- Gray Manatee Grade Level Deck Detail – DSFM diagram

Instructors and observers were not included on the accountability roster. The trainees were simply told to get on their hands and knees and follow the hose to the “fire-box” (Figure 3 - point #2). The hose entered the structure on the second level (Figure 2 - point #1); one level above ground, and entered the first of three rooms. The hose entered the second room and made a loop in the room before traveling to the next room (Figure 2 - point #3). After traversing three doors the hose traveled across a grated floor (Figure 2 - point #4) where trainees stated they could see flames below them. This catwalk traversed over a simulated engine that had a LPG fire under it. (Note: This structure was not designed or approved as a gas-fired training facility). The heat at this point was so intense the trainees had to get onto their feet and “duck-walk” across the grated floor to a ladder where they had to turn around and descend the ladder (Figure 2 - point #5) to the lower level. Once on the ground level the trainees continued to follow the hose across a concrete floor (Figure 3 - point #6). The trainees had to follow the hose through another door where they found themselves in the room with the “fire-place” (Figure 3 - point #2).

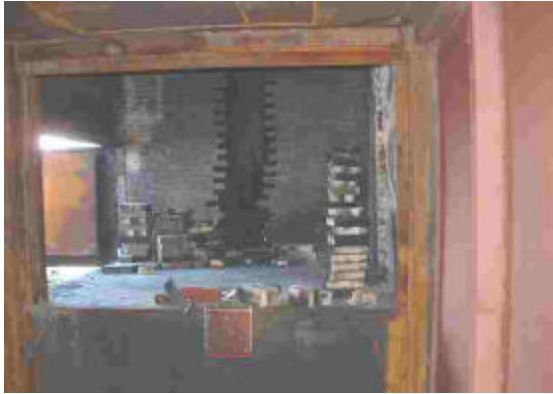
Photo 1: “Fire-Box” interior, note open hatch left to add pallets from exterior

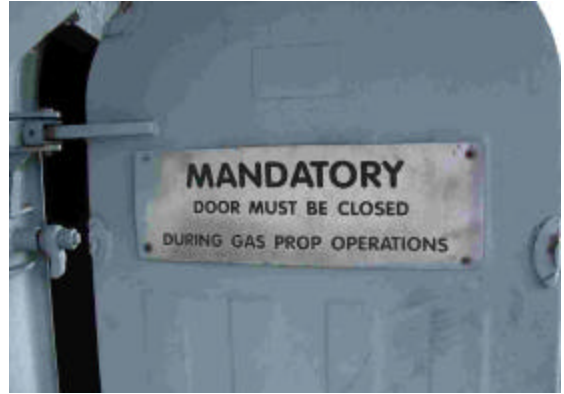
1. This was not a BFST Certified Training Facility.
2. Although not approved for gas, a gas-fueled fire was used in this training.
3. NFPA 1402 and 1403 were not complied with.

Photo 2: Sign on door advising of gas props

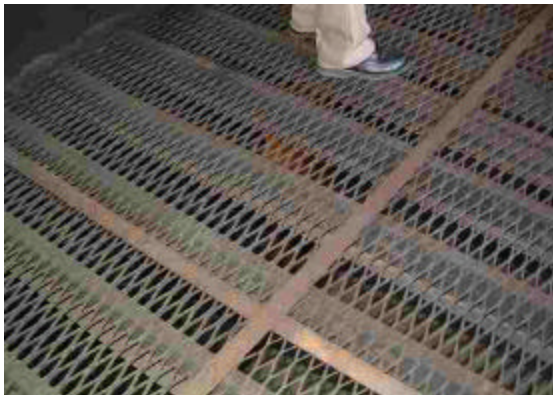
Photo 3: Grate floor trainees “duck walked” over, fires were on the level below

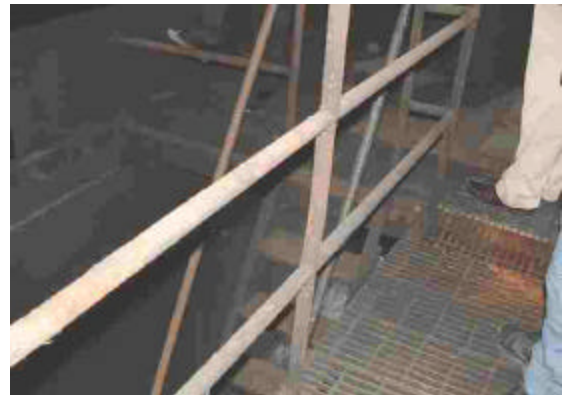
34. The trainees were required to climb up and down a ship’s ladder without prior ladder training.
35. The trainees were not afforded the knowledge of alternative escape routes/exits.

Photo 4: Stairs that trainees used to get from the entry (upper) level to fire level

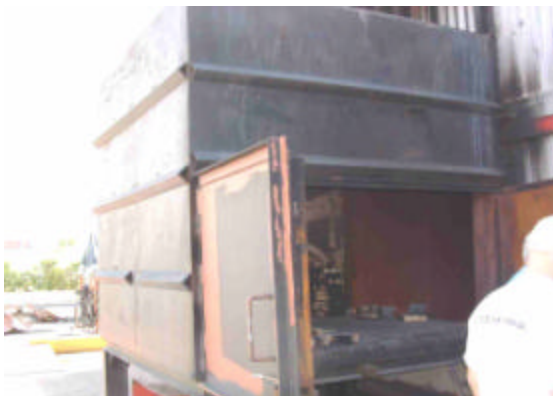
The facility's personnel constructed the topic structure. There was an air vent above the "fire-box" area controlled by a "dead man" chain. However, there was a cement block attached to the handle to prevent the vent from opening (see the attached floor plan). The training fire was in a metal "fire-box" connected to the exterior of the structure and fed from outside. To reduce the loss of heat and smoke these particular personnel added pallets to the fire from inside.

Photo 5: “Fire-Box” exterior, note open hatch to add pallets from exterior
