Incident Investigation of Two Firefighters Deaths During a Training Fire

Poinciana, Florida
July 30, 2002

BFST Safety Investigative Report 02-01

Incident Investigation – Training Fire at Poinciana
Osceola County Fire Rescue Division and City of Orlando Fire Department
July 30, 2002; Kissimmee, Florida
Prepared by the
Florida Division of State Fire Marshal
Bureau of Fire Standards and Training

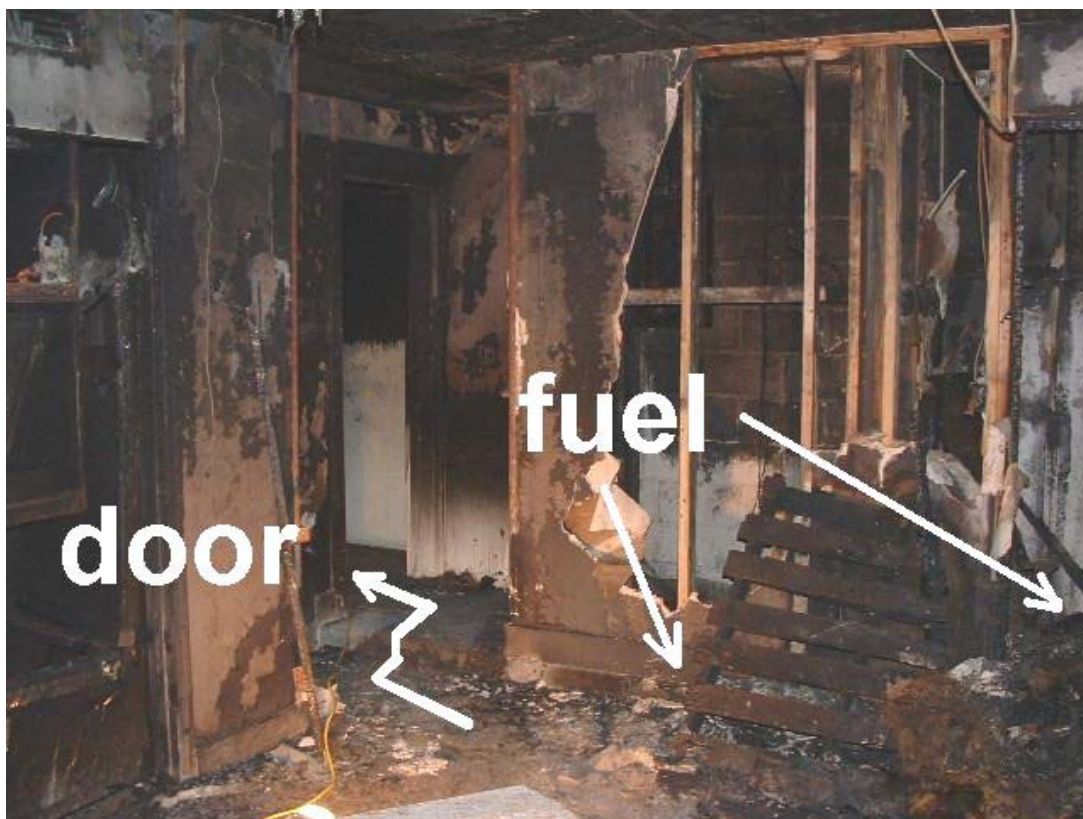
4. The fire room used was originally built as a one-car garage and had been converted into a room with block walls, one door and a fixed ¼" commercial grade glass window. Exit from the room was through two consecutive offset turns, through a 26" opening, then through a small room and through another small room, and then out another door into the dining room (see figure 1).

6. The fire was started near the only doorway in and out of the fire room (see figure 1). Prior to the window being broken, the only point for the expanding heated smoke and fire gases to vent was through the narrow door opening and the adjacent hallway. Attack Team 1 and the inside safety officer were located there and had to evacuate due to the deterioration of conditions of high heat and dense smoke. It is possible that flashover may have occurred before the window was broken, which forced Attack Team 1 and the Safety Officers out, and the then fully engulfed room vented out the window as the path of least resistance once it was broken.

Figure 1: Photo looking SW showing fuel proximity to only doorway

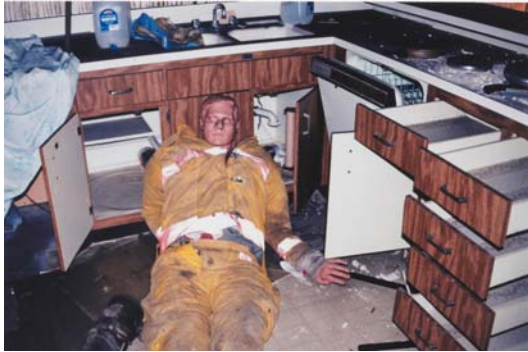
On the first evolution the mannequin had been placed in the kitchen on the west side of the structure. A bedroom on the northeast corner of the structure was utilized as the room of the live fire. The fire was located in the northwest corner of the northeast bedroom (see figure 1). Two fuel piles were used, both stacked almost upright and almost adjacent to each other, one in the closet, one in front of the closet opening. Fuel stacked in the open closet included two pallets, several scraps of wood and some hay. Outside the closet were two pallets, a hollow core interior door and 3/4 of a bale of hay. After the fire was started, a foam mattress was added to the pile outside of the closet.

Figure 2 - mannequin in kitchen

- Training mannequins should be readily identifiable as such, not to be confused with a firefighter.
 - No fire room shall be used when there are not two separate means of egress/escape available.

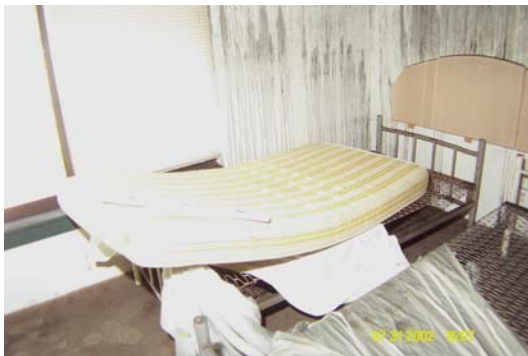
3. The fire was started in a room with too much fuel for the size of the room, including a foam mattress that was added after ignition. The mattress produced considerable smoke and heat, and there was not enough ventilation for the fuel load present. Flashover was precipitated by the combination of those two factors; high fuel load and inadequate ventilation. Refer to Addendum 1 for further information regarding related NFPA 1403 information.

Figure 3 - mattress similar to one removed from adjacent bed for use in fire room

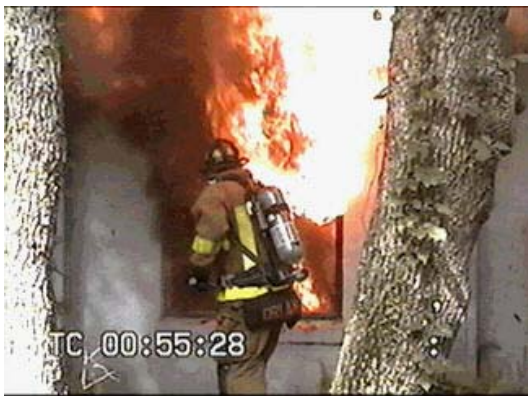
At that time AT-1 began applying water to the fire room in short bursts after the IC ordered the front northeast window to the fire room to be broken out. After the window was broken out, heavy black smoke followed shortly by flames under pressure ventilated from the window as seen on the OCFRD video recording. At that time AT-2 was ordered into the structure, but could not make entry into the hallway because the small area was full of firefighters. On the video taken by OCFRD, at least one of the two firefighters that perished can be seen, with difficulty, through the window opening. Per the participants, water that had been applied to the fire room by AT-1 caused the hallway area to fill with steam. Both safety officers had to exit the structure after receiving burn injuries.

Figure 4 - window to fire room being vented

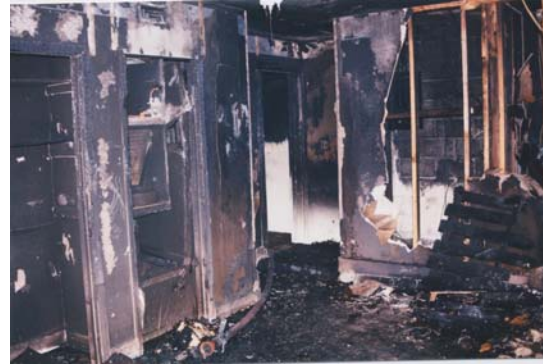
Figure 5 - fire room from corner opposite of entry/exit

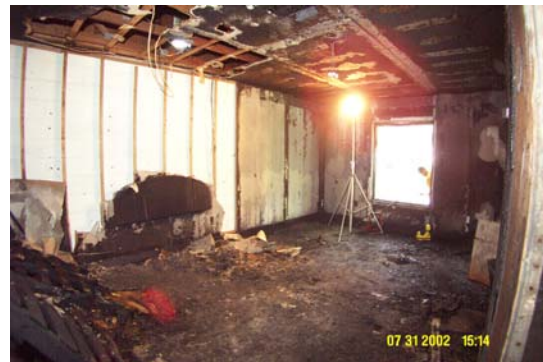
Figure 6 – Fire room looking from entry/exit towards window

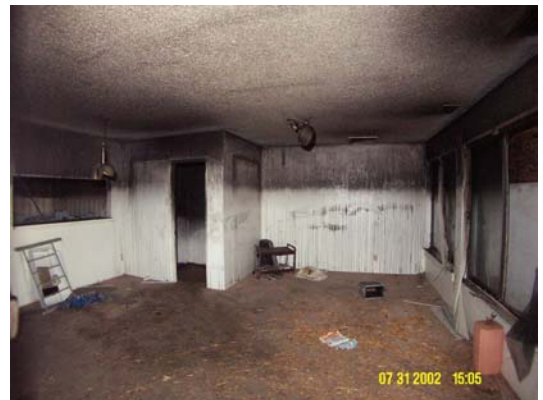
5. The layout of the house required firefighters to go through two small consecutive rooms and a narrow space to get to the fire room. This layout and the small rooms

made it difficult for the maneuvering of personnel, and was a contributing factor to the accountability and accessibility for crews trying to attack the fire.

Figure 7 - living room near front entry looking towards doorway used to enter/exit the first of two small rooms before the fire room (see floor plan)
