Incident Investigation of Firefighter Death During a Training Fire Port Everglades, Florida

**Prepared by the
Bureau of Fire Standards and Training
Florida Division of State Fire Marshal
BFST Safety Investigative Report 03-01**

Issued February 9, 2005

Incident Investigation - Training Fire at Port Everglades
Miami-Dade Fire Rescue Department and City of Hialeah Fire Department
August 8, 2003, Hollywood, Florida
Prepared by the
Florida Division of State Fire Marshal
Bureau of Fire Standards and Training

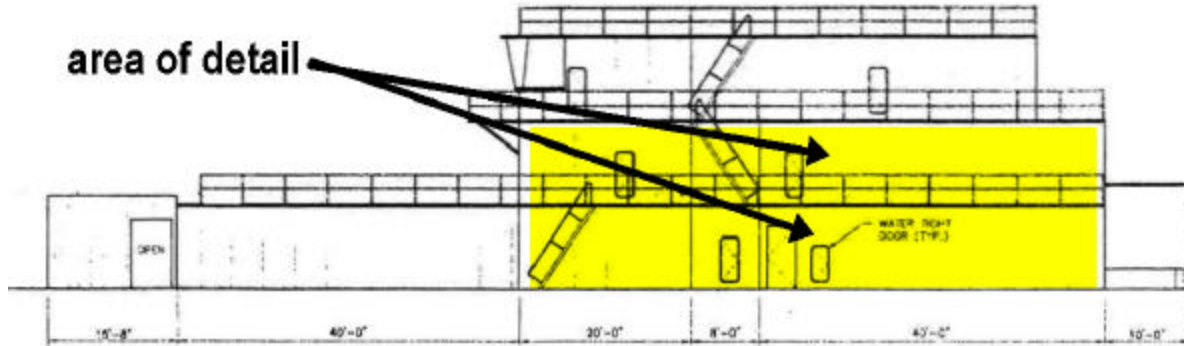
Figure 1 Port view of prop – shaded area is the areas shown in the floorplans in Figures 2 and 3 – this diagram provided by CH2MHill

According to I-1's testimony, the Accountability Officer, referred to some as the Incident Commander, a Lieutenant from Miami- Dade checked off the trainees on a roster as they entered the structure (Figure 2 - point #1). I-1 was not wearing protective clothing and SCBA.

Instructors and observers were not included on the accountability roster. The trainees were simply told to get on their hands and knees and follow the hose to the “fire-box” (Figure 3 - point #2). The hose entered the structure on the second level (Figure 2 - point #1); one level above ground, and entered the first of three rooms. The hose entered the second room and made a loop in the room before traveling to the next room (Figure 2 - point #3). After traversing three doors the hose traveled across a grated floor (Figure 2 - point #4) where trainees stated they could see flames below them. This catwalk traversed over a simulated engine that had a LPG fire under it. (Note: This structure was not designed or approved as a gas-fired training facility). The heat at this point was so intense the trainees had to get onto their feet and “duck-walk” across the grated floor to a ladder where they had to turn around and descend the ladder (Figure 2 - point #5) to the lower level. Once on the ground level the trainees continued to follow the hose across a concrete floor (Figure 3 - point #6). The trainees had to follow the hose through another door where they found themselves in the room with the “fire-place” (Figure 3 - point #2).

There are conflicting reports as to what occurred at the exit point. However, when everyone was outside it was discovered one of the trainees was missing. It is believed that the decedent lost track of the hose and wandered out of the second room he was traversing and into a chase (Figure 2 – point #9) where heated gases and smoke were venting. Handprints on the walls indicated the decedent was trying to find his way out. The Chief and I-3 reentered and searched the rooms that had been used including the burn room, using a thermal imager. While the others were looking for him, the decedent apparently found his way back to room 202 before the second search and collapsed at that point. After two attempts to retrace their path, the trainee was discovered inside the second room by I-6. I-9, who had entered to help search, grabbed the decedent and started to pull him out and I-1, without protective clothing or SCBA, entered room 201 and helped pull the decedent to the outside. The decedent’s PASS device did not sound while inside, it is believed he was mobile until just before he was found. Once outside, attempts were made to revive the decedent without success. A student advised the facility office to call 911.
